THE
GREAT EARTHQUAKE
OF JAPAN

1891.

BY
JOHN MILNE.
AND
W.K. BURTON.
PLATES BY K. OGAWA.

JOHN MILNE, F.R.S. PROFESSOR OF MINING AND GEOLOGY ; IMPERIAL UNIVERSITY OF JAPAN,

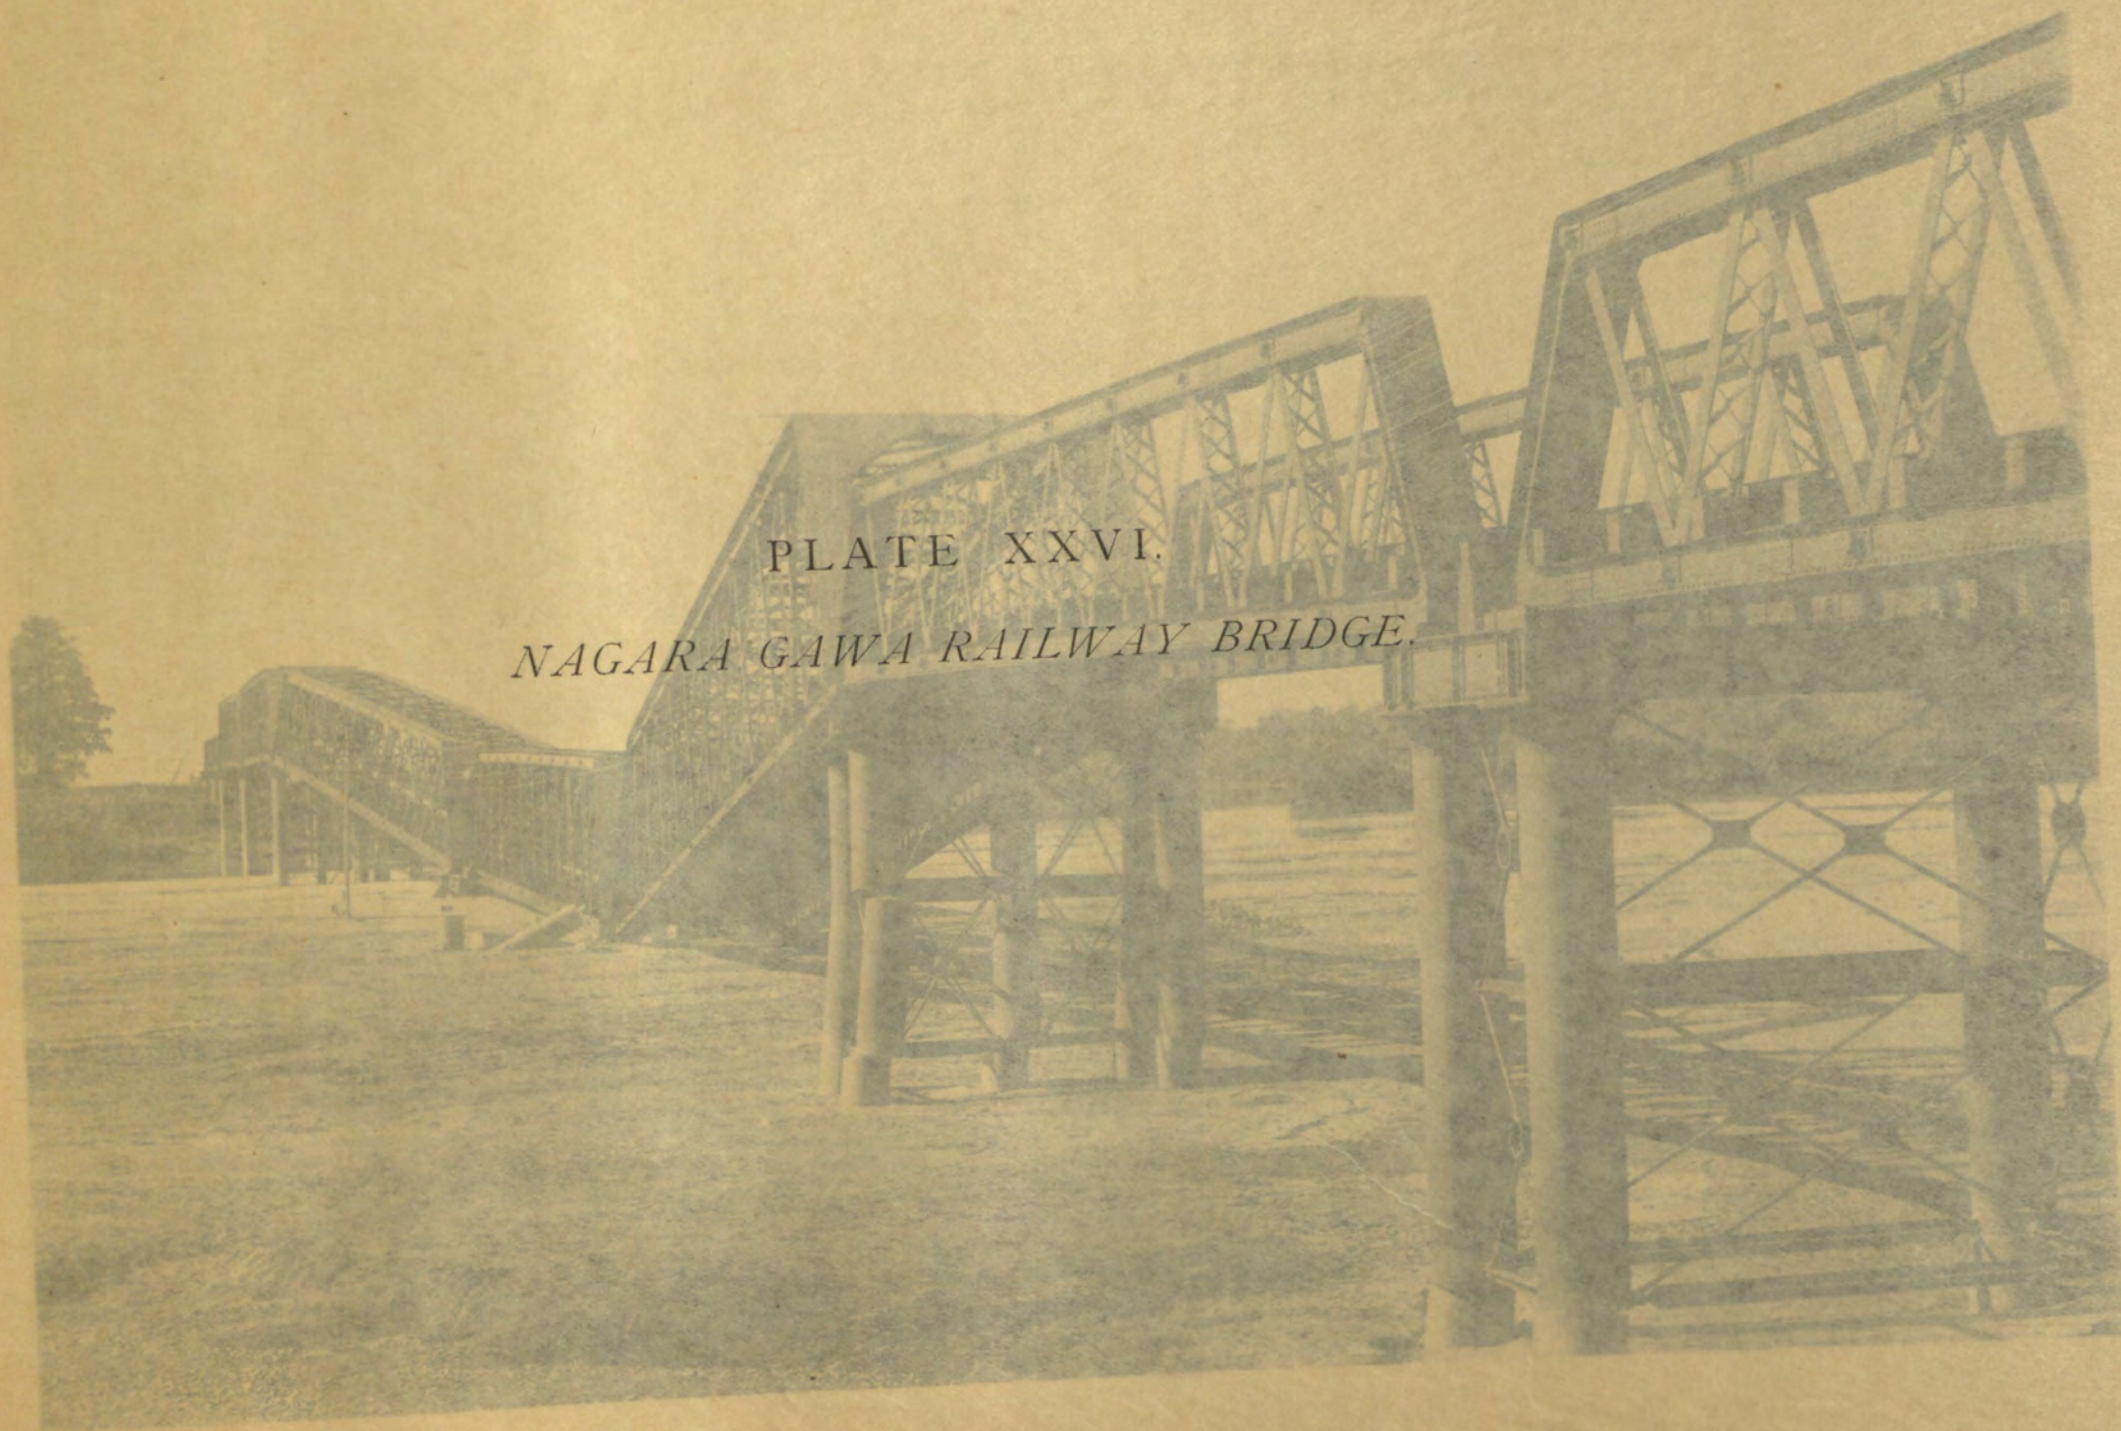
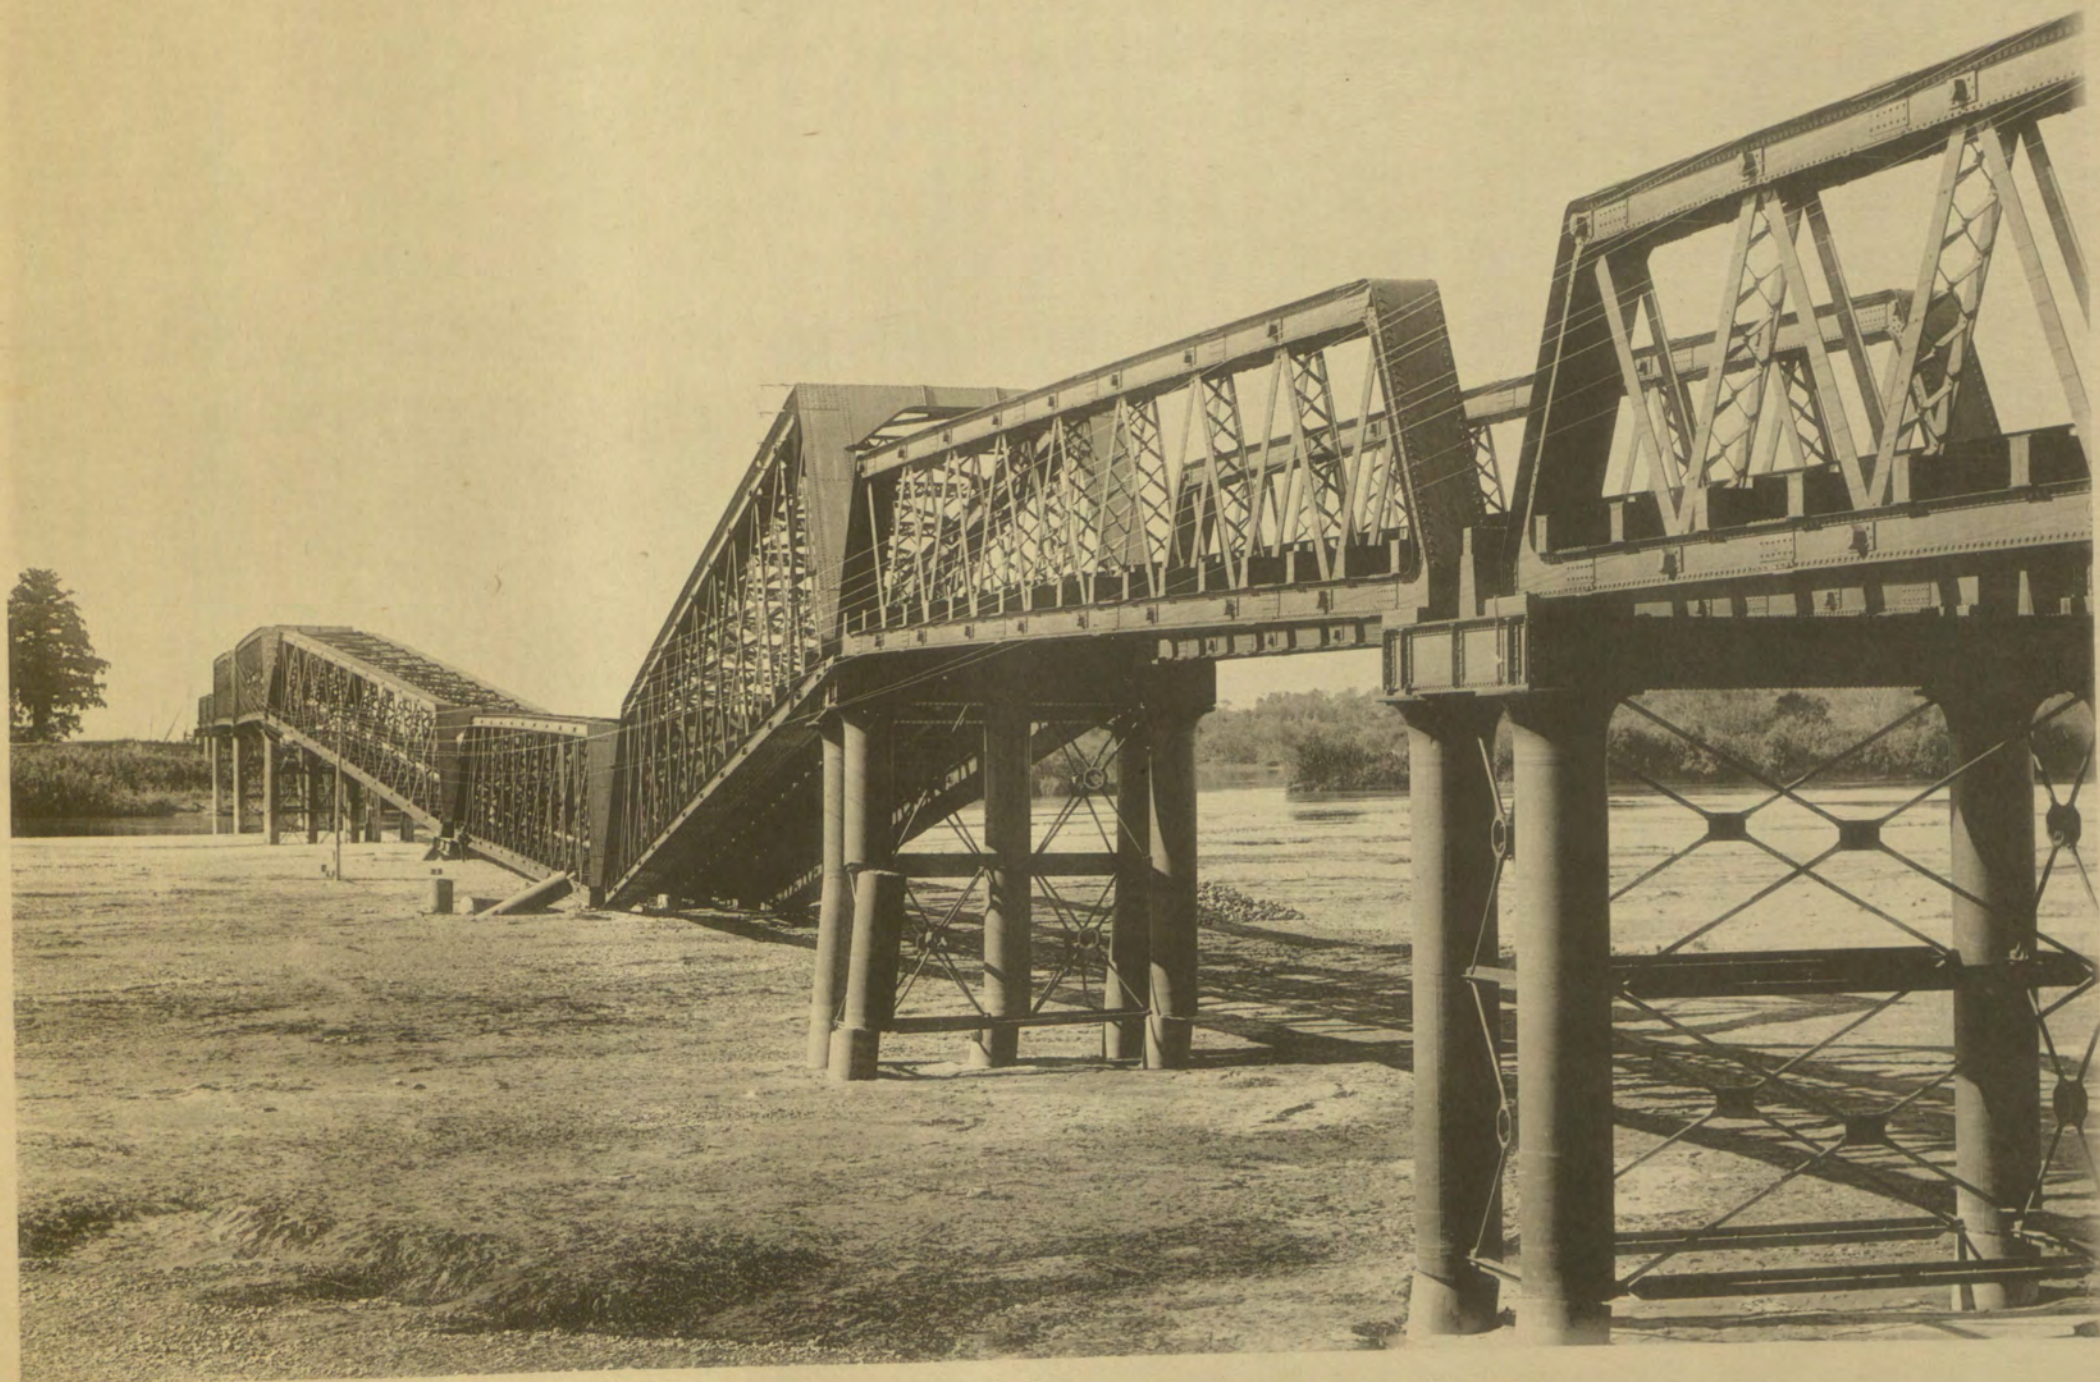
PLATE XXVI.

If near a river bank, where the piers are short and have stood, we can say, that the suddenness with which they were moved must have been *less* than so many feet per second; whereas, in the middle of a stream, where the piers are relatively high and have been fractured, the suddenness of motion must have been *more* than so many feet per second.

A bridge which has been partially destroyed by an Earthquake therefore becomes a seismometer, and leads to the determination of the rate at which motion was applied, a factor of considerable importance in designing future constructions.

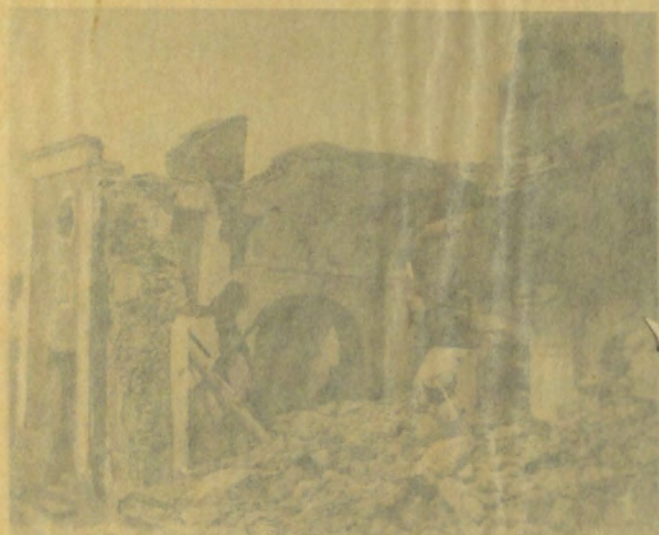
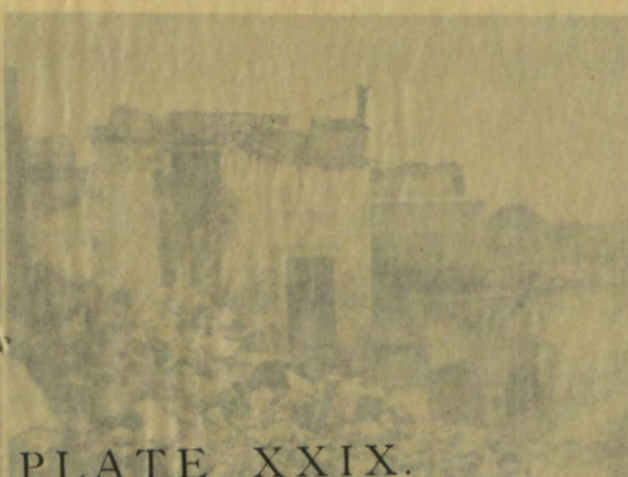
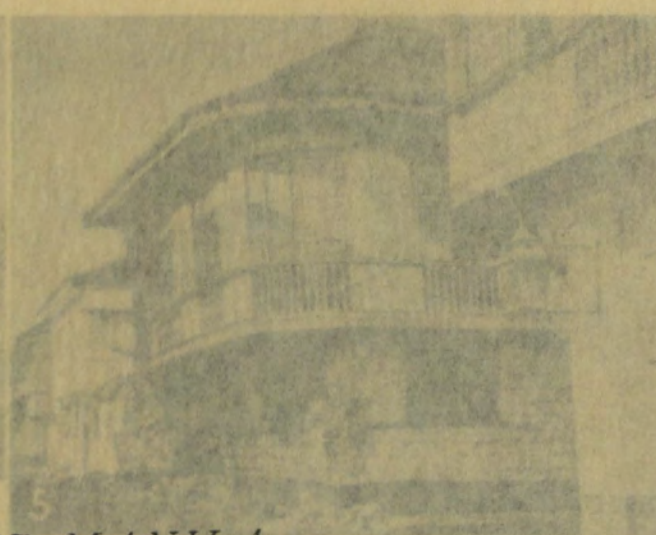
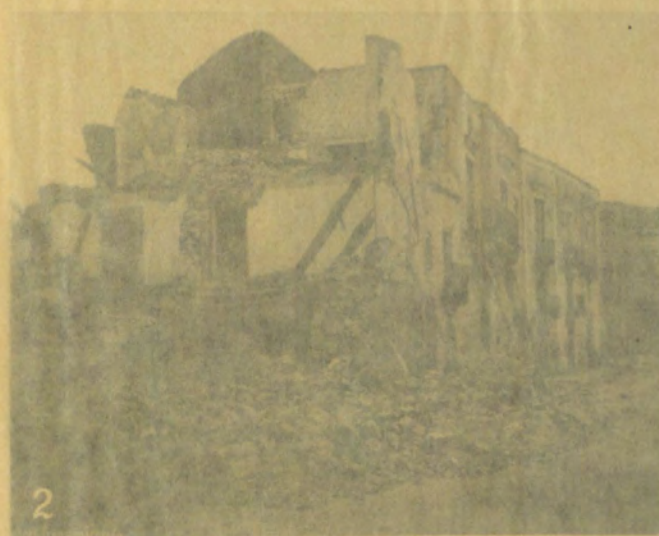
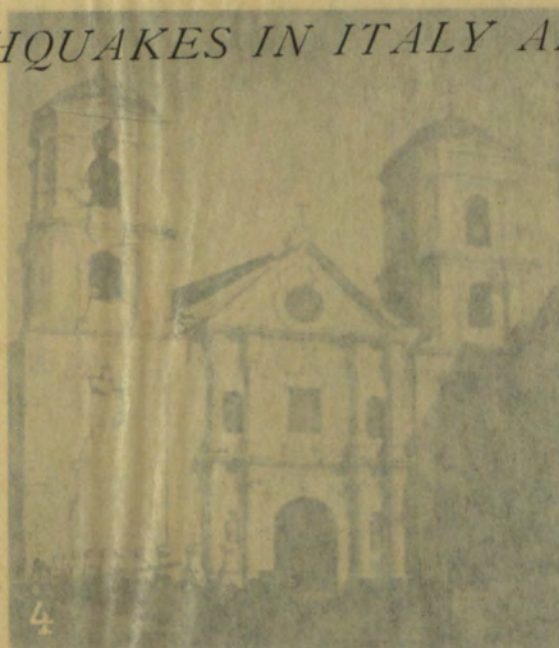
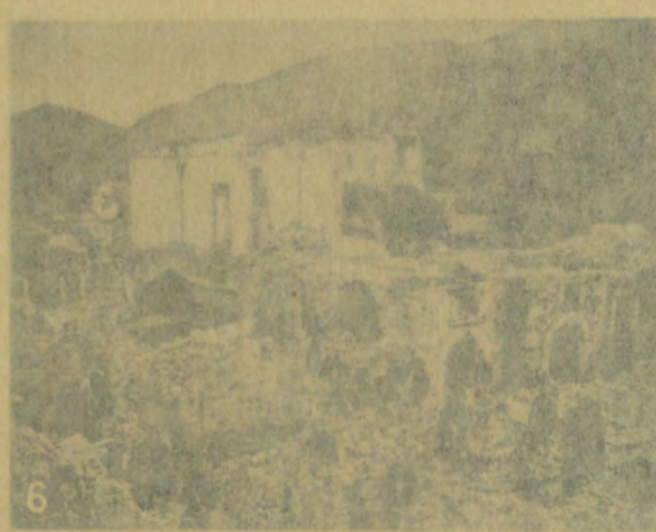
PLATE XXIX.

Although the plate may be regarded as illustrating the unsuitability of archwork in Earthquake countries, it will be observed that the masonry is mere rubble-work.

2. *Casamicciola*.—Here we have an example of the ruin of the last house in a row, which being unsupported at one end has been shot forwards.
3. *Casamicciola*.—This plate shews the giving way of a corner: two walls at right angles not having synchronized in their vibrations, they have consequently been mutually destructive.
4. *Manila*.—The more or less vertical fractures in this building shew that a series of openings in a wall constitute a line of weakness; and when a building so constructed is shaken back and forth, a rending action takes place.

A report on the disaster states that the destruction was chiefly due to bad construction, most of the houses being built of rubble.
